Manhole Inspection Summary

Manhole # S41G__027MH

Record Plat: **41G** Node: **027** Status: **Found**

Location Address: **222 s eden st**

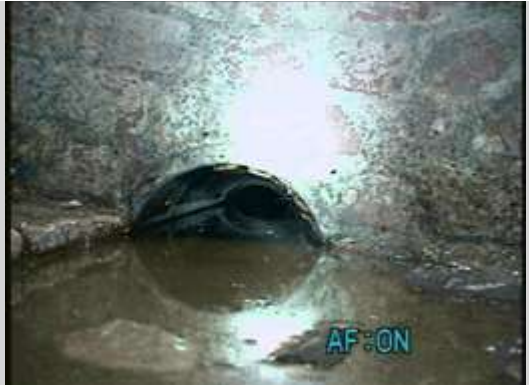
12 O'Clock Outflow

8 in. Circular Gravity Sewer
Pipe Out @ 12 O'Clock

Pipe Material: **Clay** ☐ Pipe Lined

Invert Depth: **9.68** (ft.) Flow Characteristics: **None**

Deposits: ☒ None ☐ Mud ☐ Sludge ☐ Debris ☐ Grease

Infiltration: **None** Pipe Seal Cond: **Unknown**

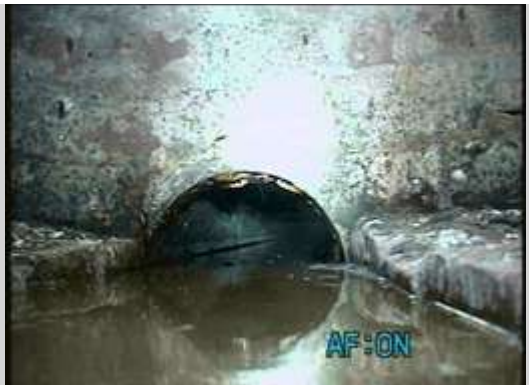
6 O'Clock Inflow

8 in. Circular Gravity Sewer
Pipe In @ 6 O'Clock

Pipe Material: **Clay** ☐ Pipe Lined

Infiltration: **None** Pipe Seal Cond: **Unknown**
